Locomotive Gear Case Study: Electro-Diesel Locomotive Engine Manufacturer Eliminates Safety Hazard & Cuts Cycle Time

Customer Profile:

Engine manufacturer specializing in Electro-Diesel locomotive engine manufacturing.

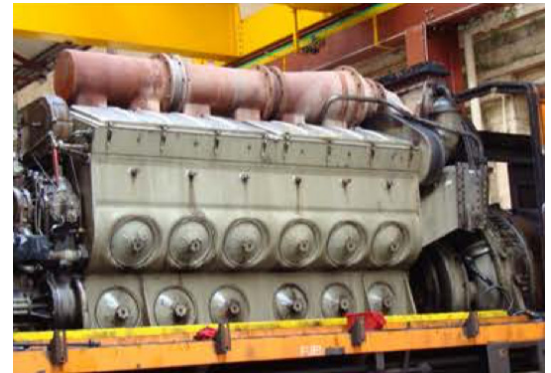
Spherical cut for a crab bolt on locomotive engine block with a hole size of 1-5/16" and a 10" reach. After clipping on safety harness to fixture, operator would climb up the fixture and manually attach cutting head, climb down, unhook harness, walk to the machine controls, press "go" to activate the back spotface cycle, and repeat. This method took one hour per spotface, as well as making the work environment unsafe.

Fully automate the back spotfacing operation with a torque bar activated Autofacer.

A massive reduction in cycle time from 1 hour to 5 minutes per spotface; 12 times faster than the previous method. All the while maintaining a 63 finish and eliminating a potentially hazardous operation. Steiner Technologies was later informed that the operator was on the verge of quitting his job to this operation. Switching to the Steiner solution saved time, improved safety and saved an employee's job.
